TLS Machine Status

Y.-C. Liu
NSRRC, Taiwan

Machine Operation

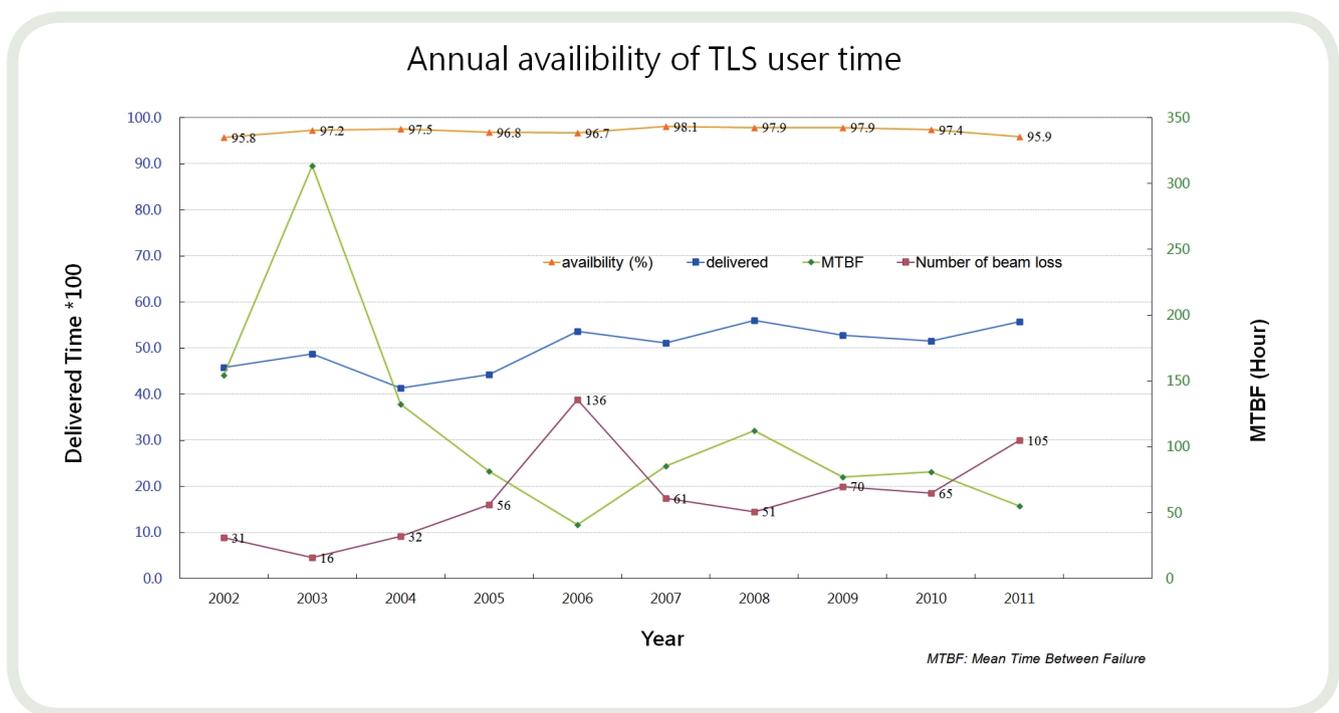
The machine operation in year 2011 has delivered 5,580.7 user hours, which was 95.9% of the scheduled user time (5,818 hours). This availability is obviously lower than those of the past few years. The major event is that the klystron tube of linac modulator had reached its end of life time and, as a result, caused 128.3 hours of downtime in April. The accelerator reliability, measured by MTBF (mean time between failures) as 55.4 hours in 2011, is also less than that of the past few years. The statistics of machine operation from 2002 to 2011 is shown in Fig. 1. Table 1 is a summary of beam parameters of TLS storage ring.

Fig. 1: The statistics of machine operation for last few years.

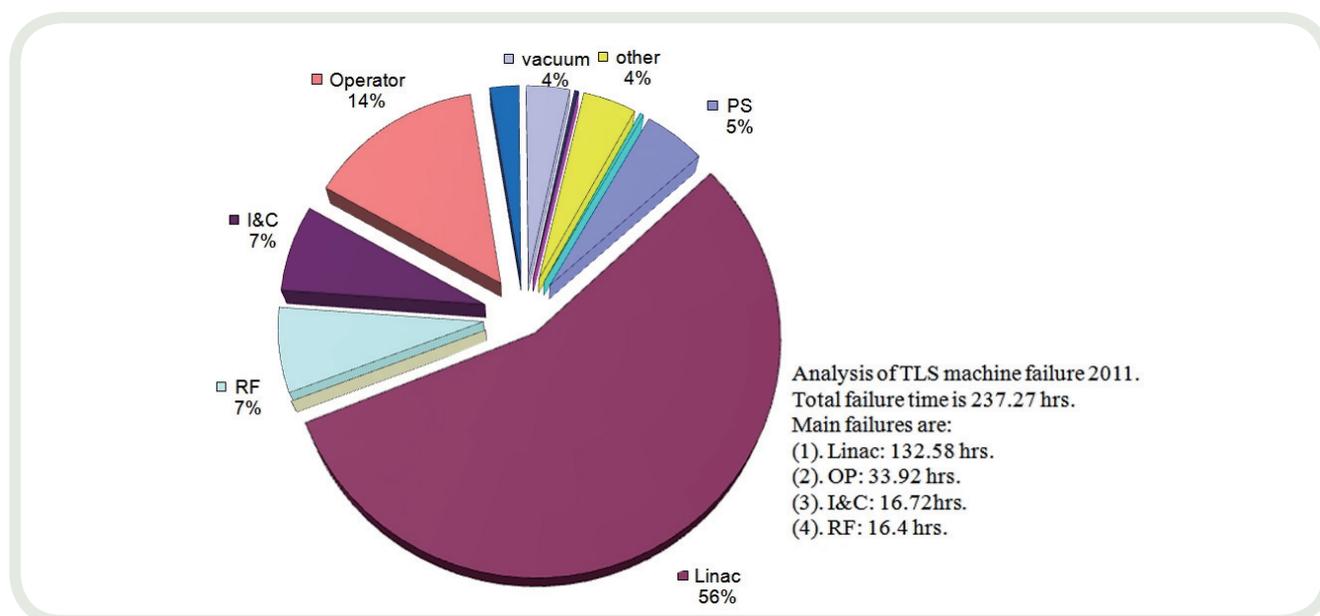
Fig. 2: The statistics of subsystem failures.

In 2011, a major event and other 105 faults contributed to the total downtime of 237.3 hours, of which 109 hours were resulted from the latter, significantly more than the average fault (62 times) that occurred during 2007-2010. The statistics of failures and the subsystems responsible for the events are shown in Fig. 2.
